TEST REPORT 241/22–530–1–EN

FIRE RESISTANCE TEST

of a 200 mm thick semi pre-fabricated lightweight loadbearing concrete ceiling slab

MARANA EUROPAN

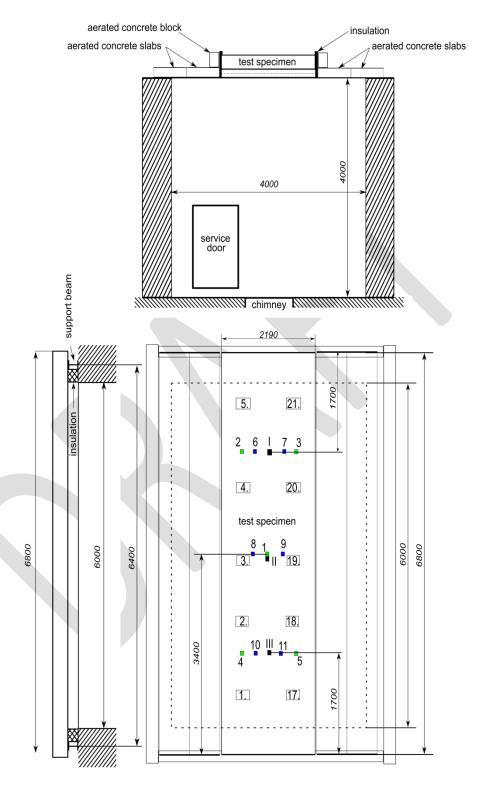
TEMPERATURE AND DEFLECTION MEASURING POINTS

- Thermocouples for average temperature rise (criteria 140K) and maximum temperature rise (criteria 180K)
- Thermocouples for maximum temperature rise (criteria 180K)
- Deformation measuring points
- Plate thermocouples for furnace control

The sketch of the furnace temperature measuring points is in Annex No. 1.

The sketch of the unexposed face temperature measuring points is in Annex No. 1.

The sketch of the deflection measuring points is in Annex No. 1.

The deflection of the test specimen was measured at three positions. Measuring points I and III were positioned at mid-width of the test specimen at one third of the span length. Measuring point II was positioned at the centre of the test specimen.

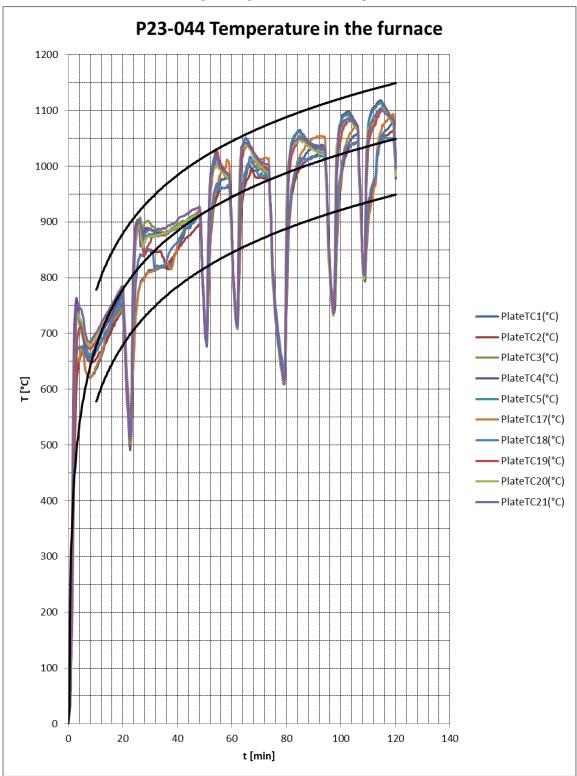
FURNACE TEMPERATURE

NOTE: The burners shut down six times during the testing time, in 21st, 48th, 59th, 75th, 96th and 106th minute. The testing time was extended to cover the period when the furnace was shut down.

The diagram and the table of the temperatures inside the furnace are in Annex No. 2.

Due to the furnace error, the furnace burners shut down several times during the testing time. The burners shut down six times; in 21st, 48th, 59th, 75th, 96th and 106th minute. As a result of shut down burners, the standard time-temperature curve (described in Clause 6.2) limits were exceeded. The testing time was extended to cover the period when the furnace temperature was not in the limits, to reach fully valid testing conditions for classification time 90 minutes.

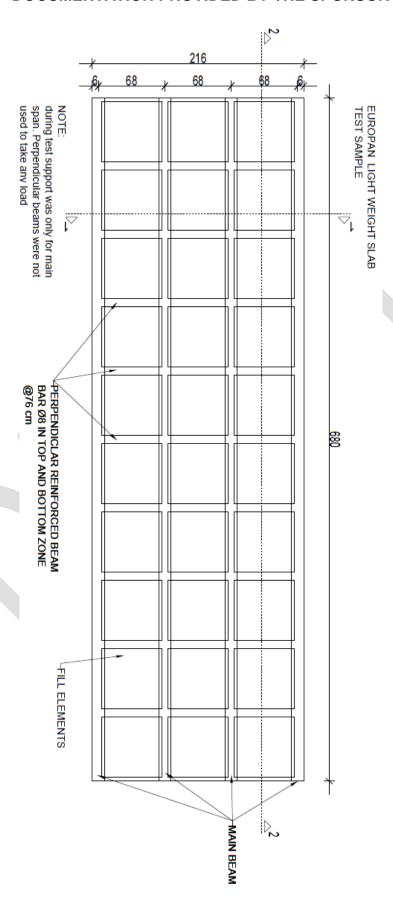
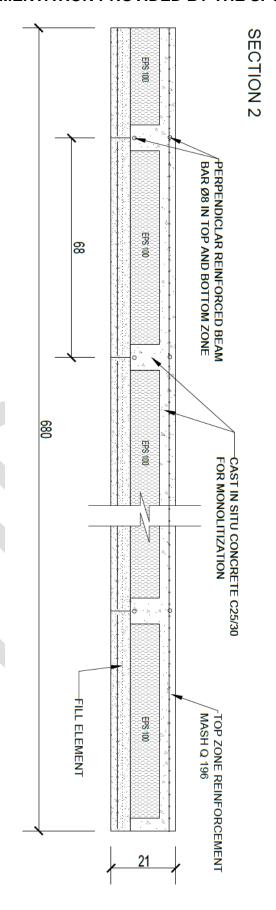
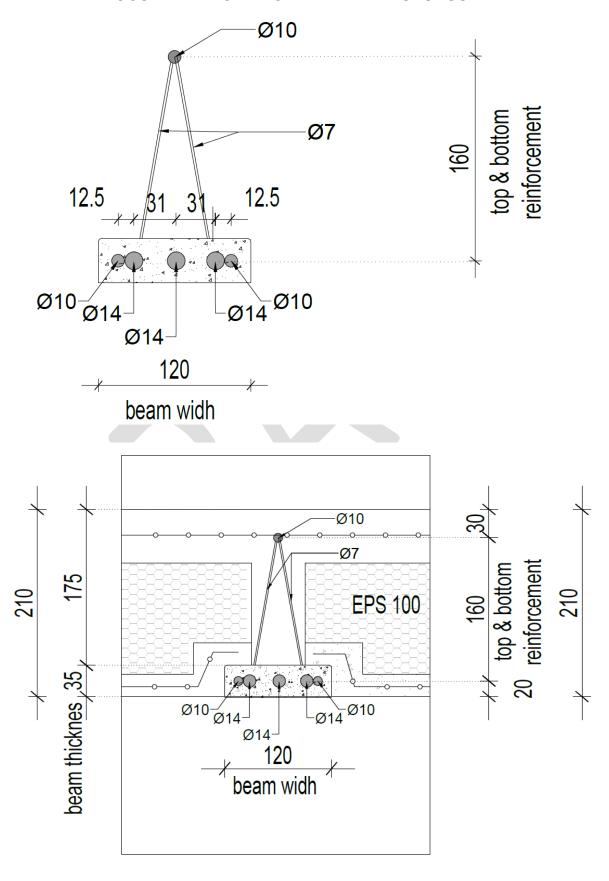
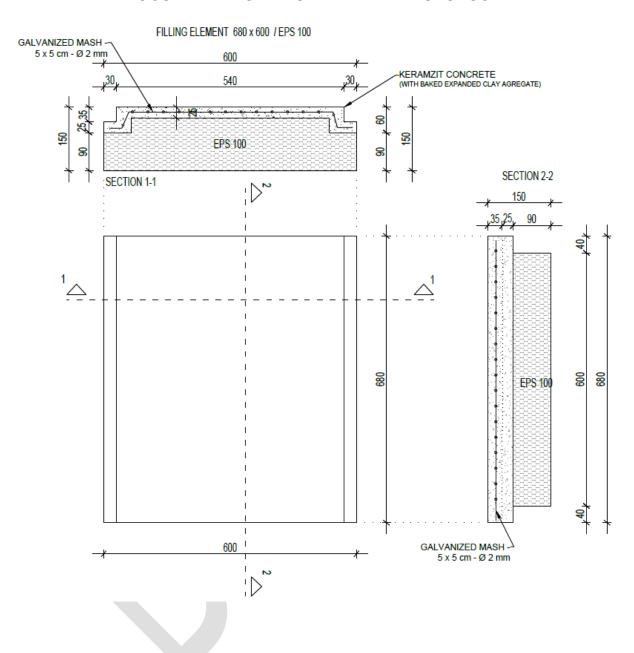
Details of the test specimen are shown in the documentation provided by the sponsor in Annex No. 6.

Test specimen was light slab construction made of pre-fabricated elements. The loadbearing of the slab was provided using four main beams, positioned 680 mm apart, with a width of 120 mm and a thickness of 35 mm. Distance between the top and the bottom reinforcement was 160 mm. In the main beam, three reinforcement bars with a diameter of 14 mm and two reinforcement bars with a diameter of 10 mm were placed. The diameter of the top reinforcement bar was 10 mm. In between main beams, filling elements of dimensions $600 \times 680 \times 150$ mm were placed on the beams. On top, top-zone reinforcement mesh Q 196 was placed over the entire surface of the slab. In between filling elements, perpendicular reinforcement Ø8 mm beam bars were placed in top- and bottom-zone. Top surface and all cavities between filling elements were cast with C25/30 concrete (in Annex No. 6 compressive strength test report from 29. 11. 2021). Measured moisture content at the day of the test in the concrete was 1,6 moisture content in % of dry weight. Measurement was made close to the centre of the test specimen with Gann Hydromette HT 85 T.

Filling elements were made of formed KEMOPOR EPS100 blocks (declaration of conformity in Annex No. 6) with a thickness of 125 mm, produced by the company Kamenović d.o.o., that were casted with Keramzit (Liapor) C16/20 concrete with expanded clay aggregate, produced by the company Lias Österreich GesmbH (certificate in Annex No. 6). Keramzit concrete was reinforced over the entire surface of each filling element with 50 x 50 mm grid galvanized mesh with 2 mm diameter bars.

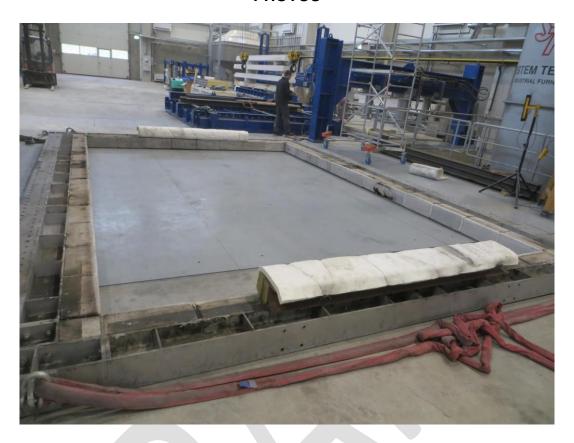
Photo No. 046997d-001: test specimen supporting construction

Test specimen was positioned on two steel beams HEA 160, of dimensions $152 \times 160 \times 2180$ mm. Over each HEA 160 beam, 25 mm thick ceramic wool was laid in order to protect the supporting construction from heat exposure. In addition to ceramic wool, mineral wool lamellas were placed in the cavity of each beam. Test specimen was laid on top of each insulated beam. In addition to the ceramic wool insulation, rock wool slabs of dimensions 100×160 mm were placed in front of each support beam towards the opening in the frame.

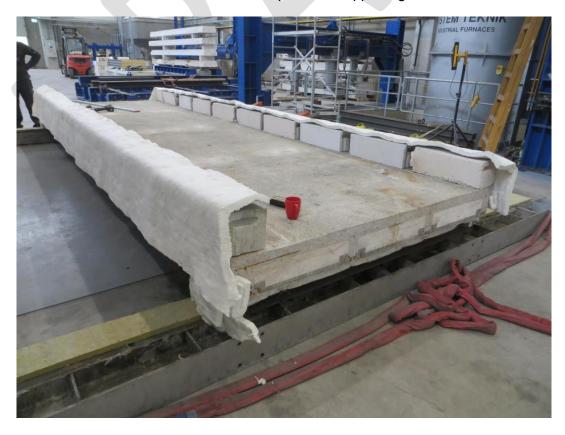
Photo No. 046997d-002: test specimen laid on the supporting construction

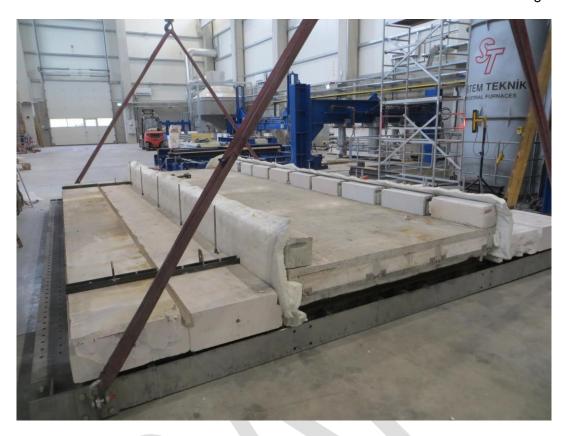
Photo No. 046997d-019: test specimen placed on the test frame and slabs placed at the longer edges

The test specimen was closing the top opening of a combo furnace of dimensions $4000 \times 6000 \times 4000$. The part of the furnace that was not covered by the test specimen was covered with aerated concrete slabs.

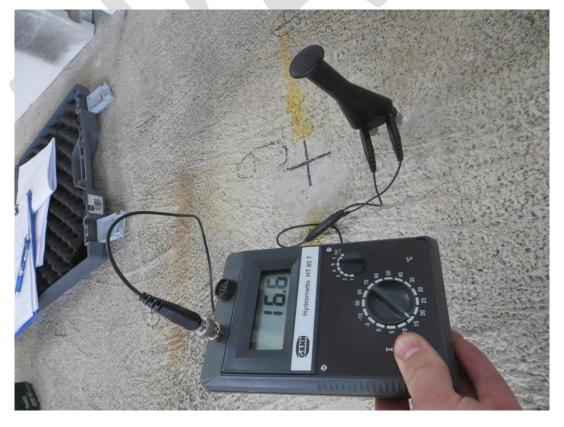
Photo No. 046997d-025: measuring of moisture content in the test specimen

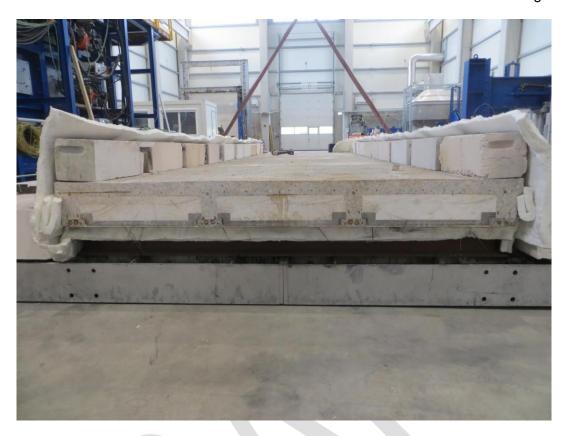
Photo No. 046997d-020: short edge of the test specimen

Gaps and cavities between the test specimen and the aerated concrete slabs, placed at the sides of the test specimen, were sealed by means of 25 mm thick ceramic wool in such a way that bending of the test specimen was allowed.

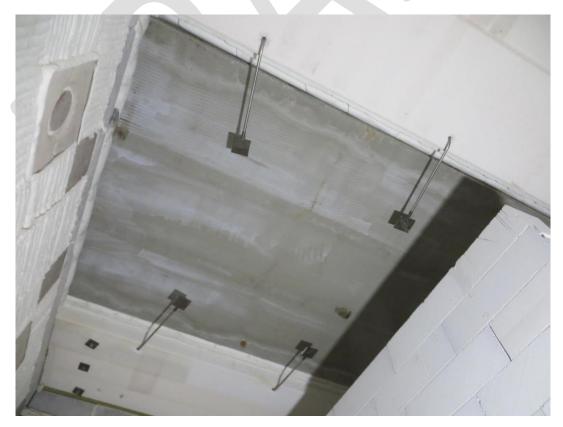
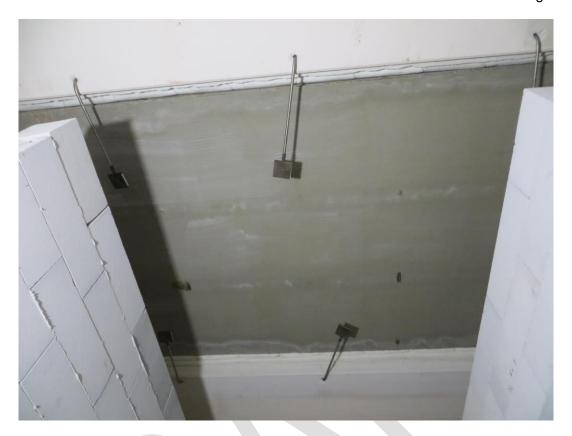
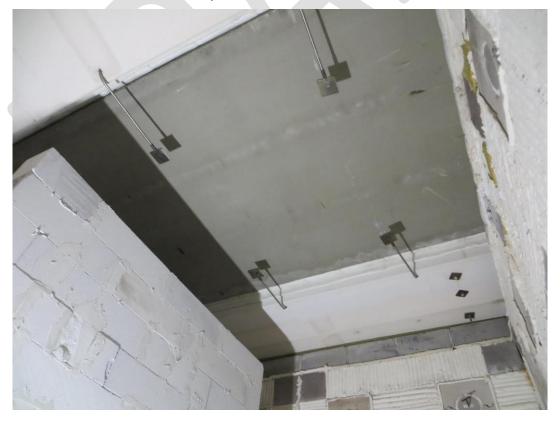
Photo No. 046997d-027: exposed face before the commencement of the test

Photo No. 046997d-028: exposed face before the commencement of the test

Photo No. 046997d-029: exposed face before the commencement of the test

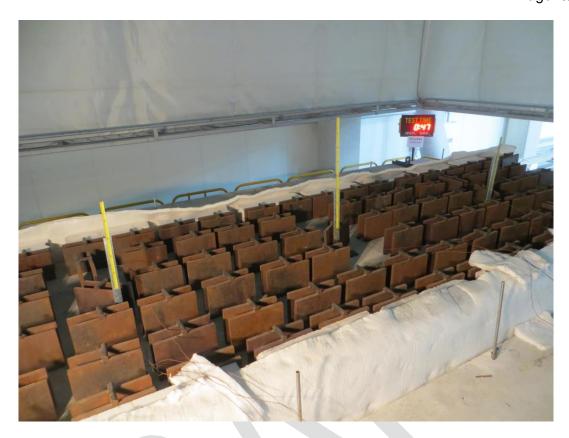
Photo No. 046997d-050: loaded test specimen at the commencement of the test

The 200 mm thick semi pre-fabricated lightweight loadbearing concrete ceiling slab **MARANA EUROPAN** was loaded using 112 weights, each with a weight of 20 kg, equally distributed over the surface of the test specimen. By the request of the sponsor the test load applied on the test specimen surface was 150 kg/m².

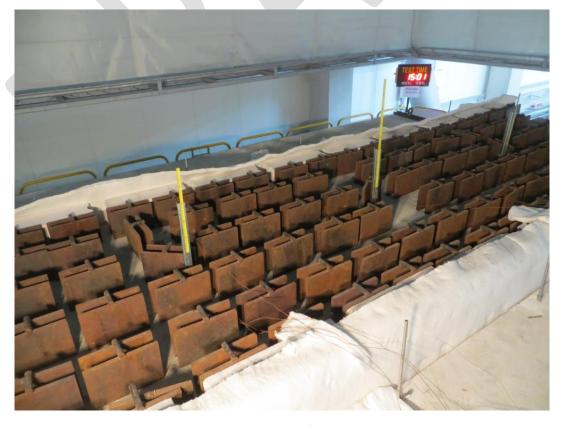
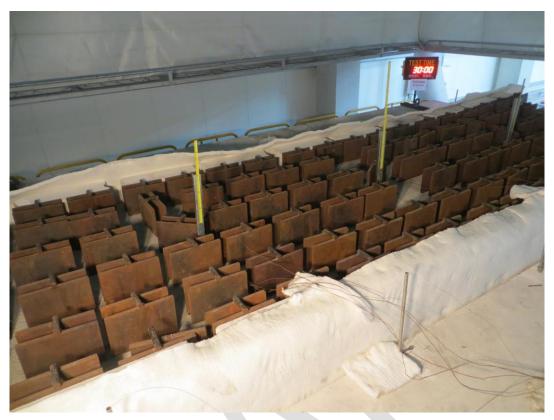
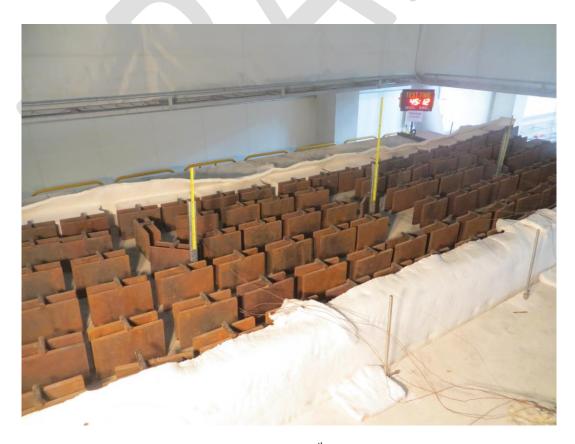
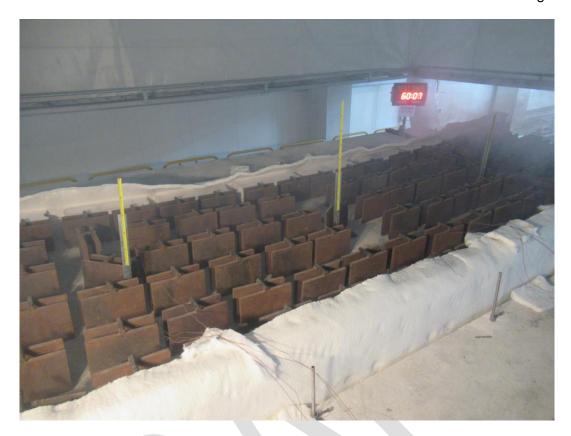
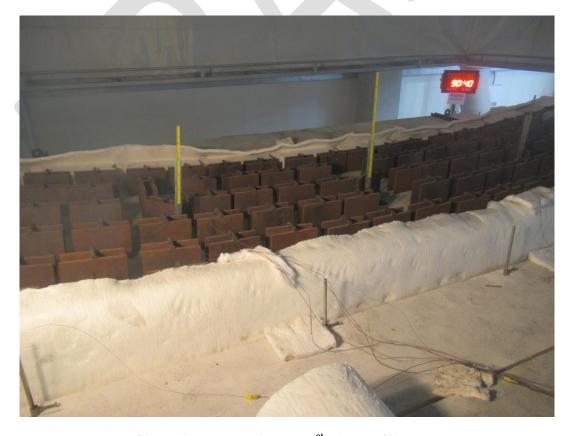
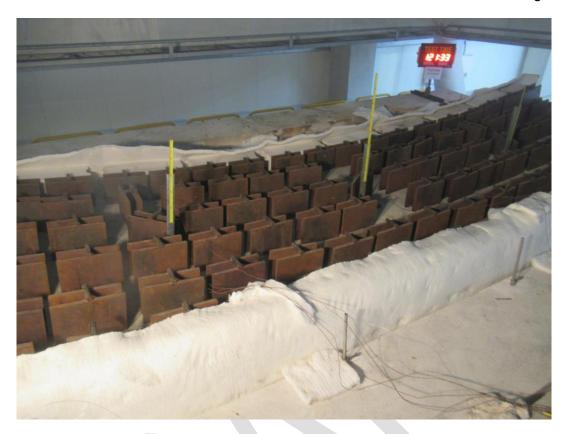
Photo No. 046997d-058: 16th minute of the test

Photo No. 046997d-069: 30th minute of the test

Photo No. 046997d-081: 46th minute of the test

Photo No. 046997d-094: 61st minute of the test

Photo No. 046997d-123: 91st minute of the test

Photo No. 046997d-151: 122nd minute of the test

TIME [min]	SIDE	OBSERVATION
0		The test commenced;
15		Smoke leakage at the short edge;
122		The test was discontinued on the sponsor's request.

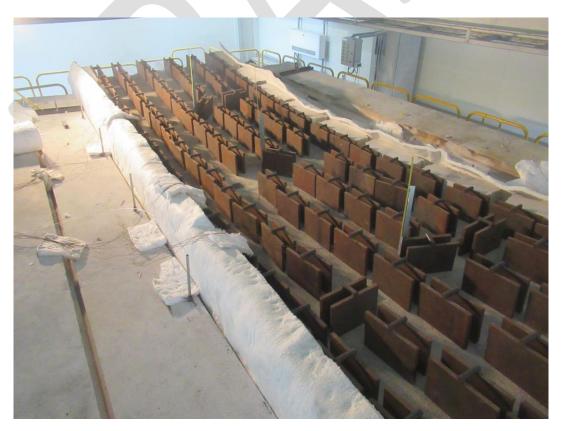
Photo No. 046997d-155: unexposed face at the end of the test

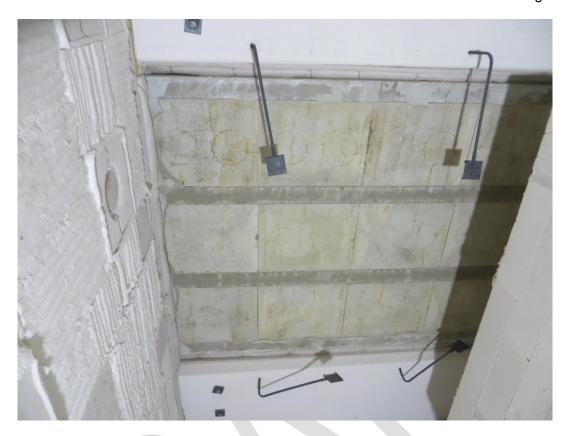
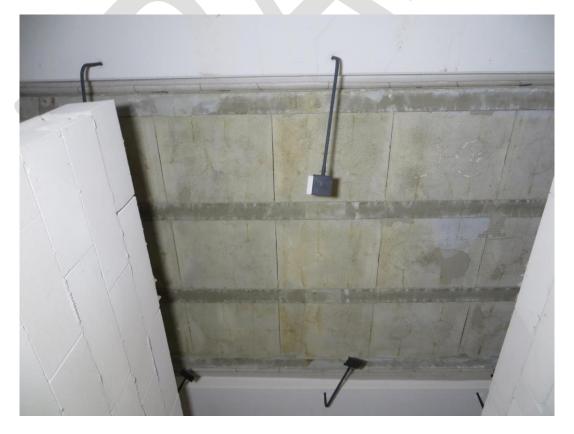
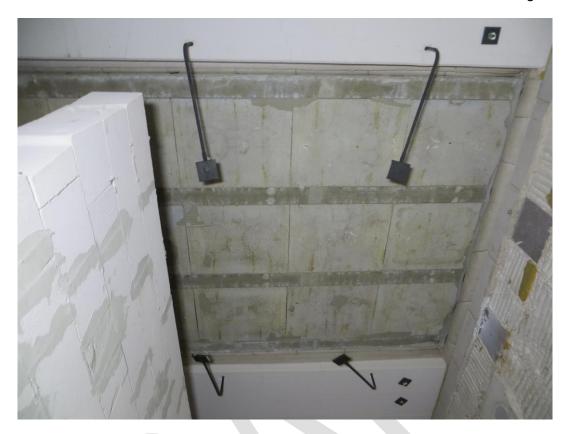
Photo No. 046997d-161: exposed face at the end of the test

Photo No. 046997d-162: exposed face at the end of the test

Photo No. 046997d-163: exposed face at the end of the test
